Manhole Inspection Summary

Manhole # S13C__003MH

Insp Date: **6/23/09 2:28 PM**

Location Address: **616 DUKELAND ST**

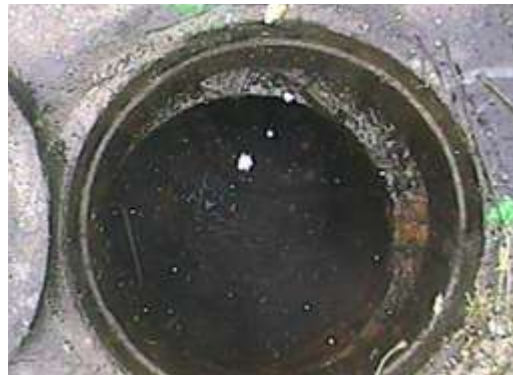
Defect 2

Frame Offset: **3** (in.) Condition: ☒ Sound ☐ Cracked ☐ Leaks

offset frame

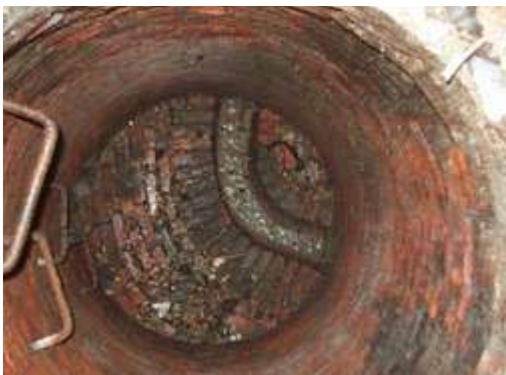
Defect 1

Infiltration: ☐ None ☐ Joint ☐ Cracks ☐ Mortar ☐ Roots ☒ **Wall**

Condition: ☐ Sound ☒ **Cracked** ☐ Root Intrusion ☐ Loose Brick ☐ Deteriorated

Condition: ☐ Sound ☒ **Cracked** ☐ Root Intrusion ☐ Deteriorated ☐ Leaks ☐ Debris

infiltration of corbel; cracked of barrel and bench

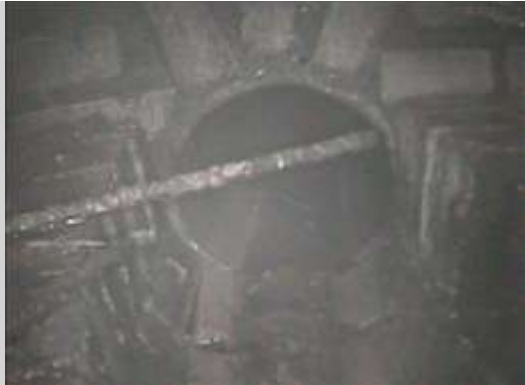
12 O'Clock Outflow

8 in. Circular Gravity Sewer
Pipe Out @ 12 O'Clock

Infiltration: **None** Pipe Seal Cond: **Sound**

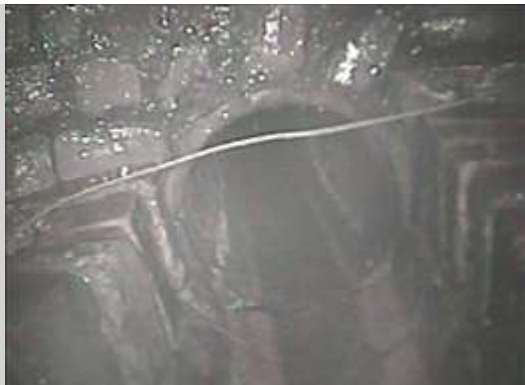
3 O'Clock Outflow

8 in. Circular Gravity Sewer
Pipe Out @ 3 O'Clock

Infiltration: **None** Pipe Seal Cond: **Sound**

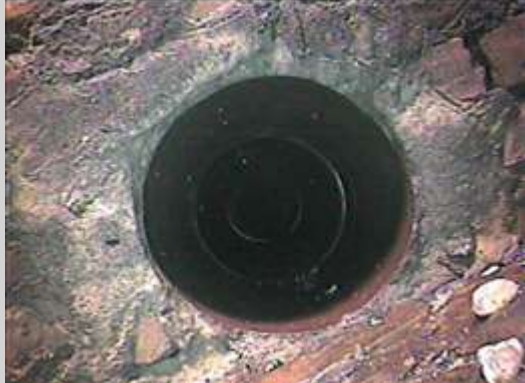
6 O'Clock Inflow

Pipe In @ 6 O'Clock

Infiltration: **None** Pipe Seal Cond: **Sound**
